INDOOR AIR QUALITY ASSESSMENT

**Saugus Town Hall
Main Street
Saugus, Massachusetts**

Prepared by:
Massachusetts Department of Public Health
Bureau of Environmental Health Assessment
Emergency Response/Indoor Air Quality Program
August 2003

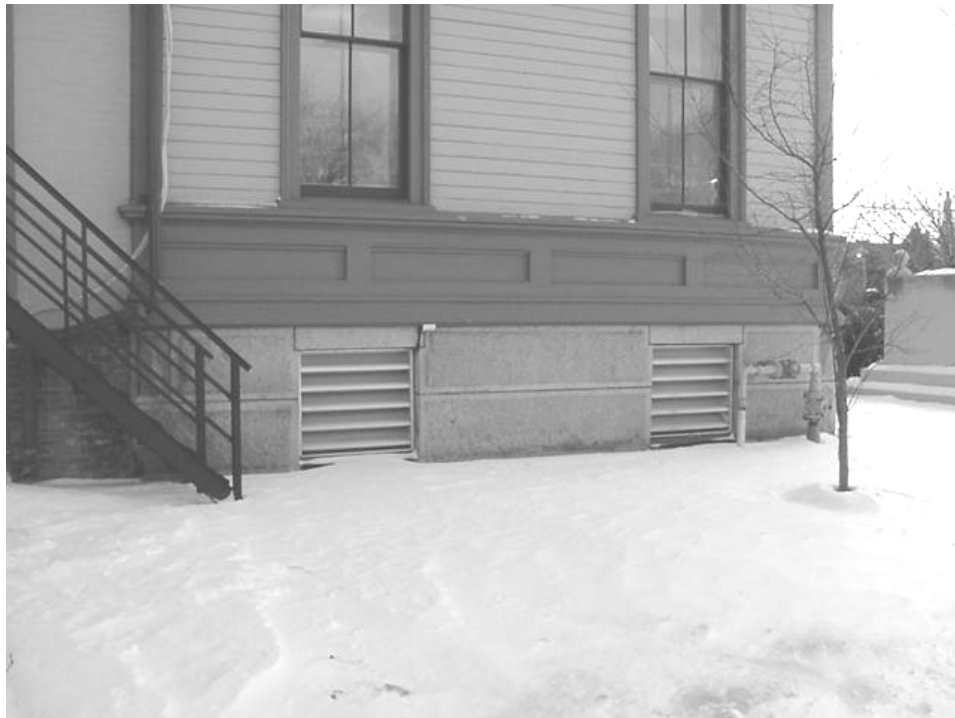
Picture 1

It can be seen from the tables that carbon dioxide levels were elevated above 800 ppm (parts per million) in three of nineteen areas surveyed, indicating adequate ventilation in most areas of the building. Fresh, heated air is supplied by air-handling units (AHUs) located in a mechanical room on the ground floor. Fresh air is drawn into the AHU through fresh air intakes on the exterior of the building (see Picture 1) and delivered to occupied areas via ceiling-mounted air diffusers (see Picture 2). The ventilation system is not equipped with an exhaust component to return air back to the AHUs. Without a mechanical exhaust system, normally occurring environmental pollutants can build up and lead to temperature/comfort complaints.

Fresh Air Intakes for HVAC System

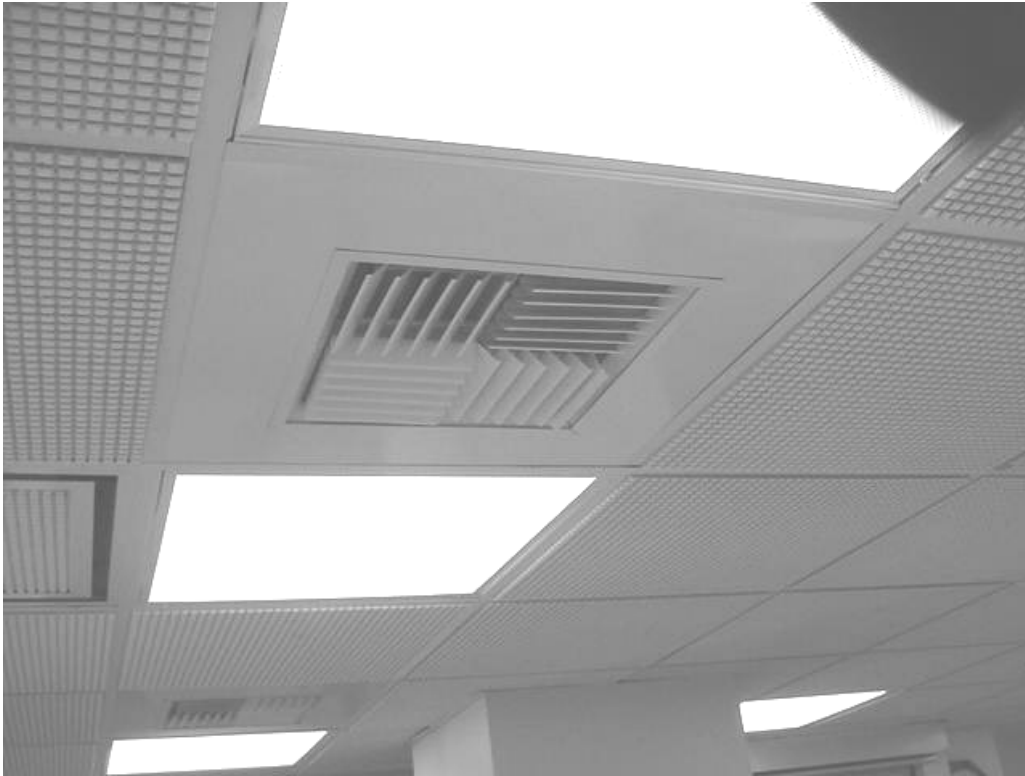
Picture 2

Ceiling-Mounted Fresh Air Diffuser

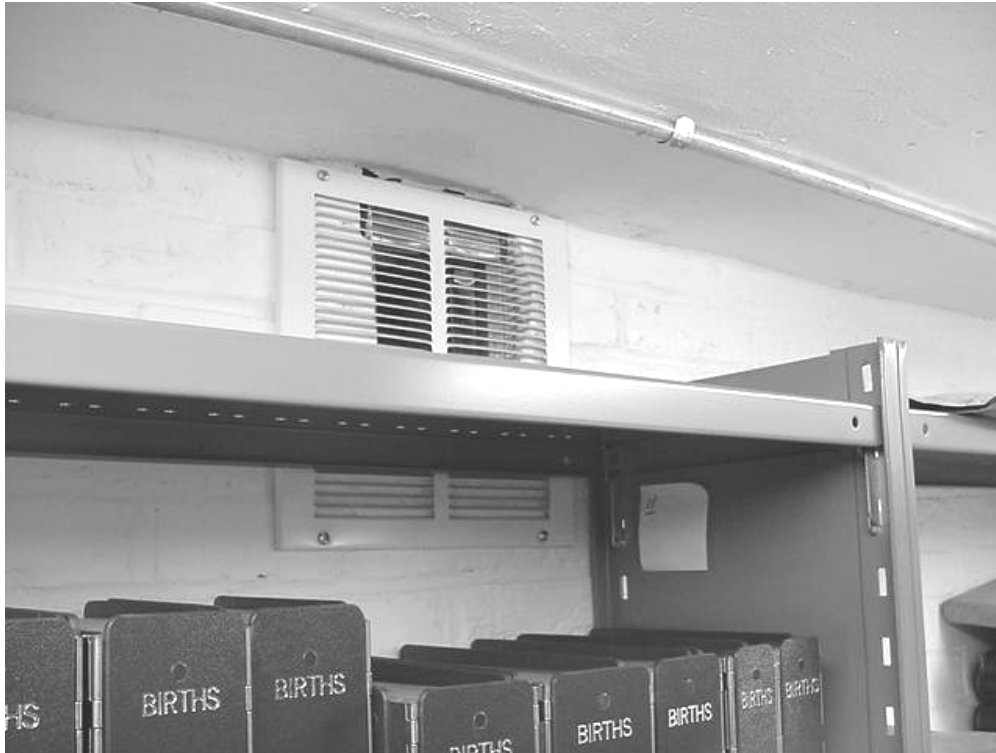
Picture 3

Ductwork and a vent/grill were installed in the safe area (see Pictures 3 & 4). No airflow was detected from the vent during the assessment; therefore, the function of the vent (supply/exhaust) could not be determined.

Grill installed in Vault Area

9. Determine the function of the vent in the vault. If mechanical, reactivate; if not, examine the feasibility of installing local exhaust ventilation.

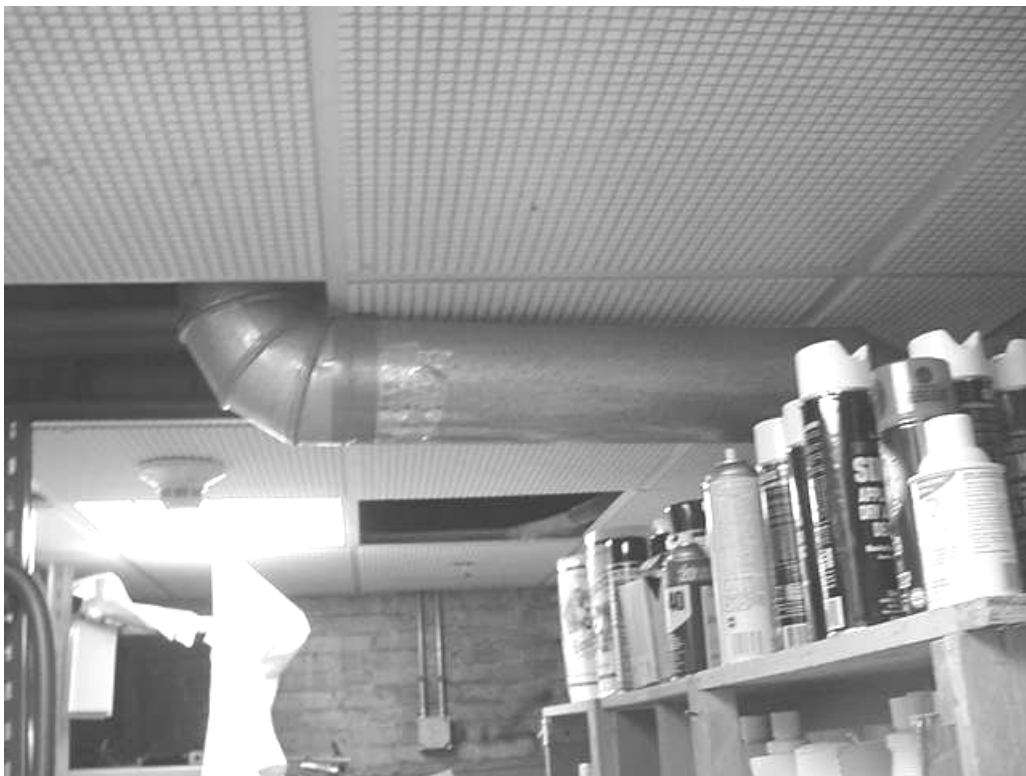
Picture 4

Ductwork Attached to Grill in Vault Area

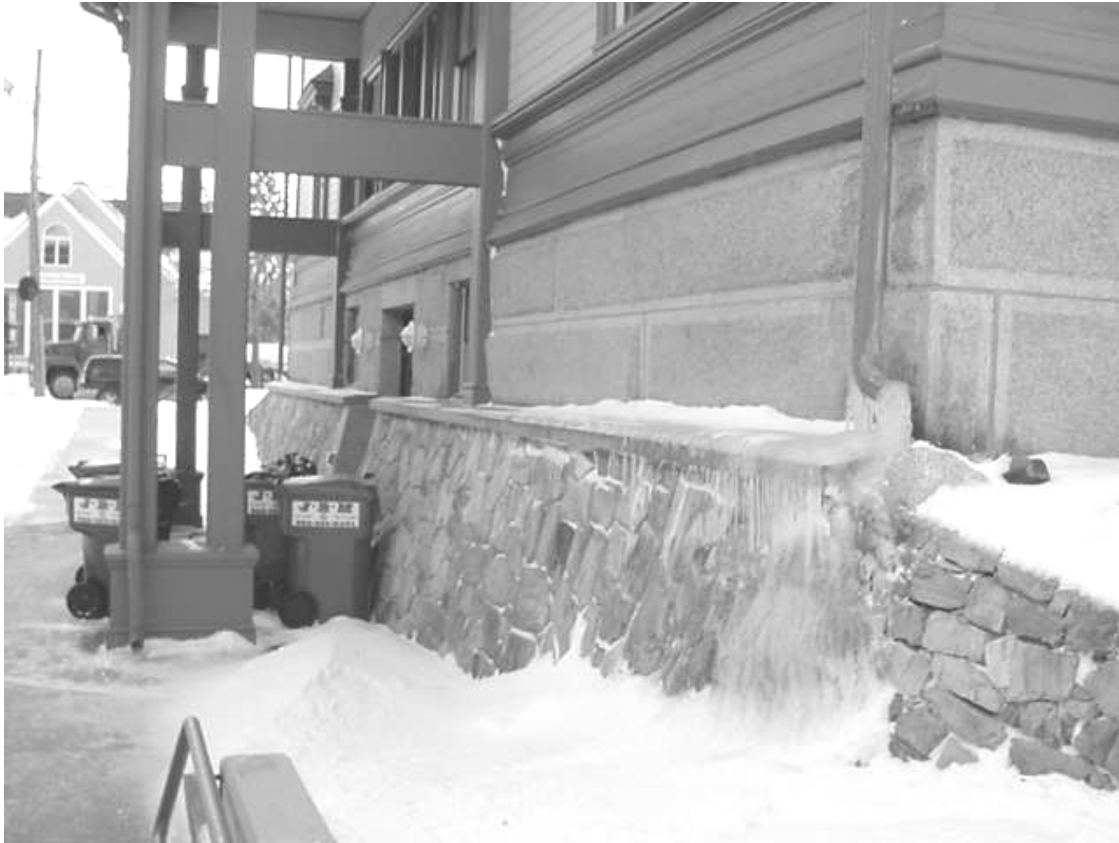
Picture 5

The STH is equipped with a gutter/downspout system to direct rainwater away from the building. In some cases the gutter/downspout system empties water directly against the foundation (see Pictures 5). These conditions can undermine the integrity of the building envelope and provide a means of water entry into the building through capillary action through foundation concrete and masonry (Lstiburek & Brennan, 2001).

Downspout/Gutter System Emptying Water Against Foundation

7. Redirect or extend downspouts to direct water away from the base of exterior walls.
8. Contact a licensed plumbing contractor to investigate complaints/leakage of odor from the drains in the accounting office.

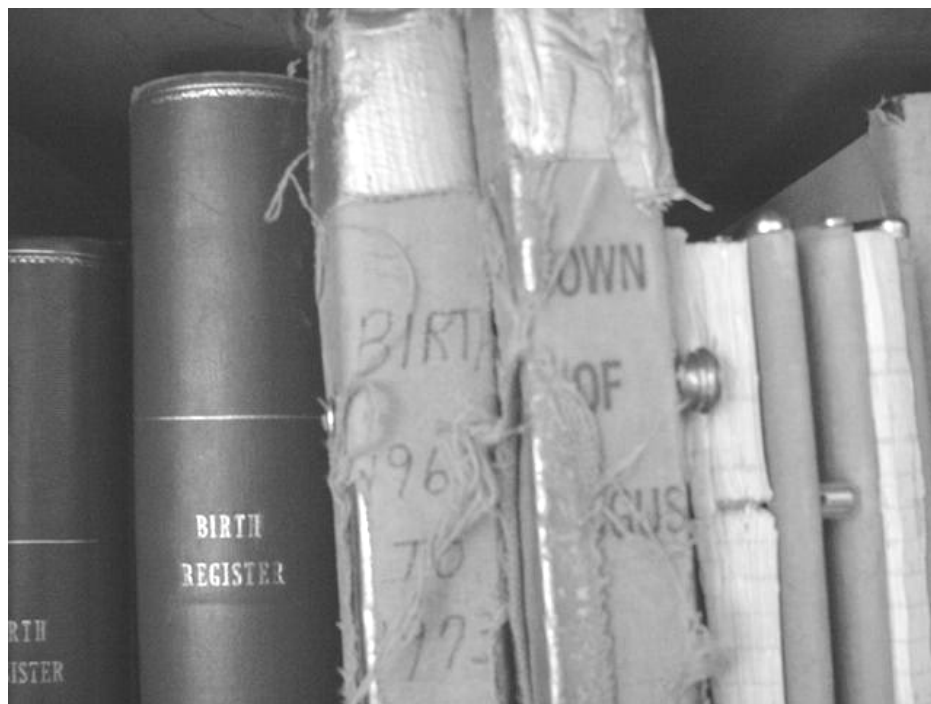
Picture 6

Exacerbation of allergies and skin, respiratory and eye irritation (s) were reported by employees in the Town Clerks office and by employees that visit the vault. The vault, located at ground level and the clerks office on the first floor both house historic documents of very old age. Many of the items (e.g. ledgers) have been water damaged over the years, are dusty and/or have bindings in disrepair (see Pictures 6 & 7). The book in Picture 8 was taken from a shelf in the vault at random and contained a bird feather and dander. Occupants could not recall a roosting problem with birds. Accumulated dirt, dust, potential mold from water damaged/damp books and animal dander can all serve as sources of irritation. No mechanical or natural ventilation could be identified within the vault. Without mechanical ventilation these irritants are neither diluted nor removed from the environment. In recent conversation with Ms. Rosati, the town has contracted Service Master, Inc., a professional remediation firm to conduct cleaning and disinfection in the vault (Rosati, 2003).

Disintegrating Binders of Old Records

10. Determine future preservation, handling and/or storage actions for materials currently stored in the vault area and in the Town Clerk's office. The inherent conditions of aged/vintage materials (e.g. ledgers/records) have created an environment conducive to eye, skin and respiratory irritation. These boxes, documents, books and other stored

materials will continue to be a source of mold and/or particulates. In this case, ventilation alone cannot serve to reduce or eliminate these materials. As an initial step, options concerning the preservation of materials stored in this area should be considered. Since many historical records appear to be stored in these areas, an evaluation concerning disposition of these materials must be made. Porous materials that are judged unworthy of preservation, restoration or transfer to another media (e.g. microfiche or computer scanning) should be discarded. Where stored materials are to be preserved, restored or otherwise handled, an evaluation should be done by a professional book/records conservator. This process can be rather expensive, and may be considered for conservation of irreplaceable documents that are colonized with mold. Due to cost of book conservation, disposal or replacement of moldy materials may be the most economically feasible option.

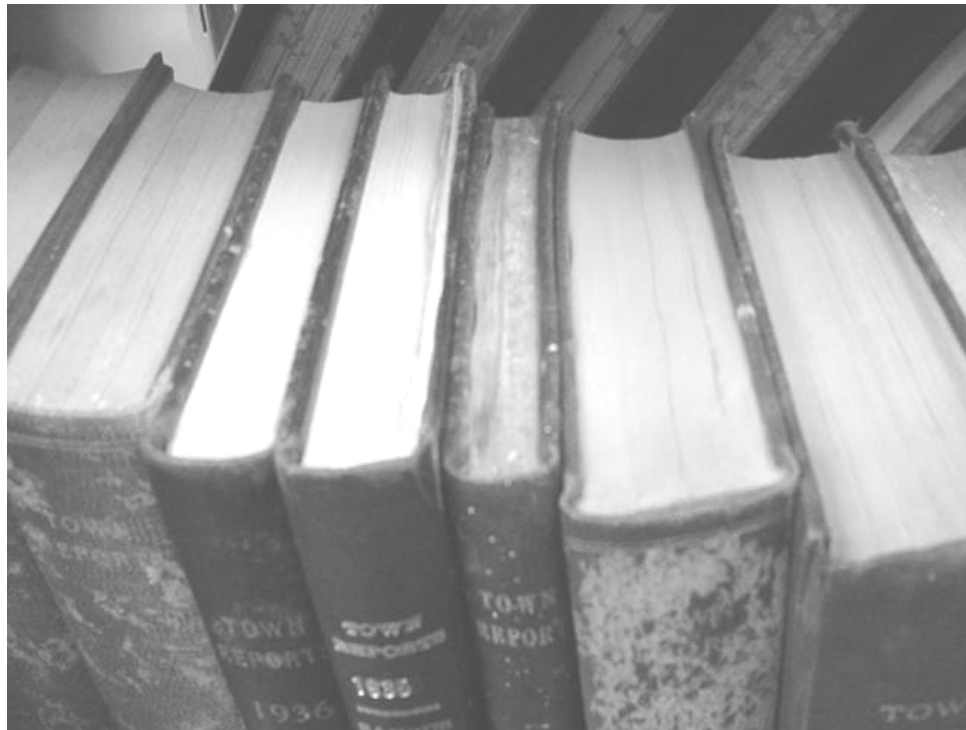
Picture 7

Old Town Records Discolored/Water Damaged

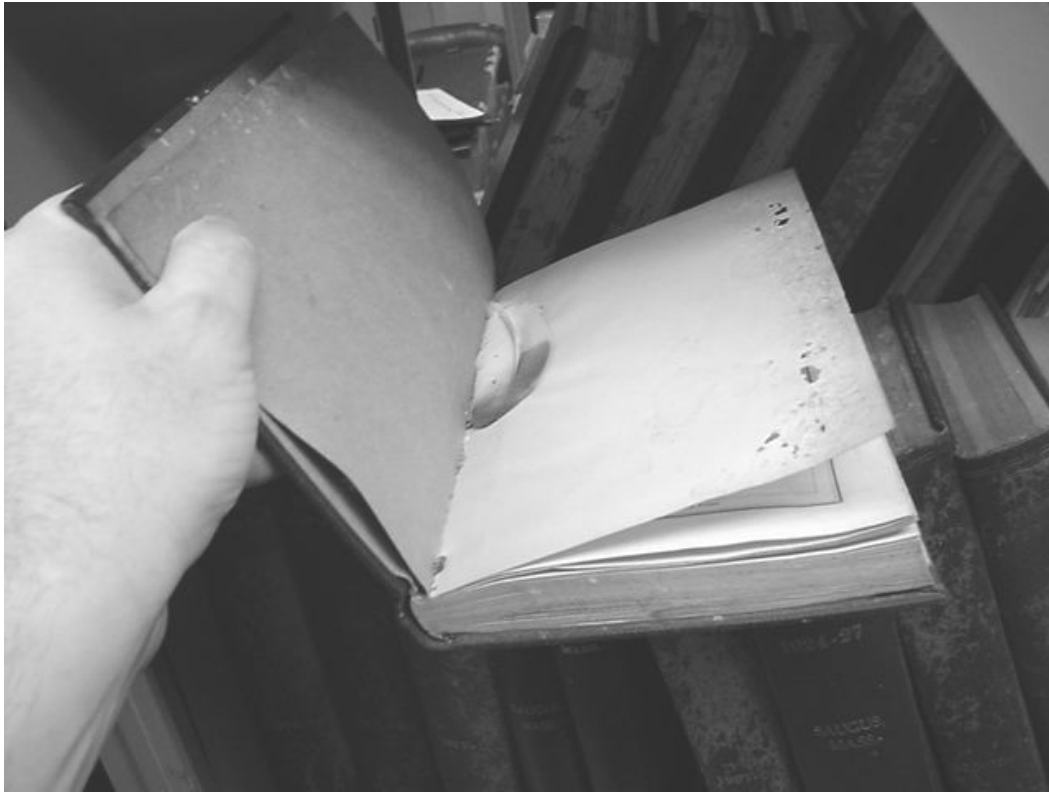
Picture 8

Book Chosen at Random from Shelf in the Vault, Note Bird Feather and Dander
